STATUS OF NORTH VIETNAMESE RAILROADS

Report No. II  
CIA/PIR 75043

DATE Oct. 1966

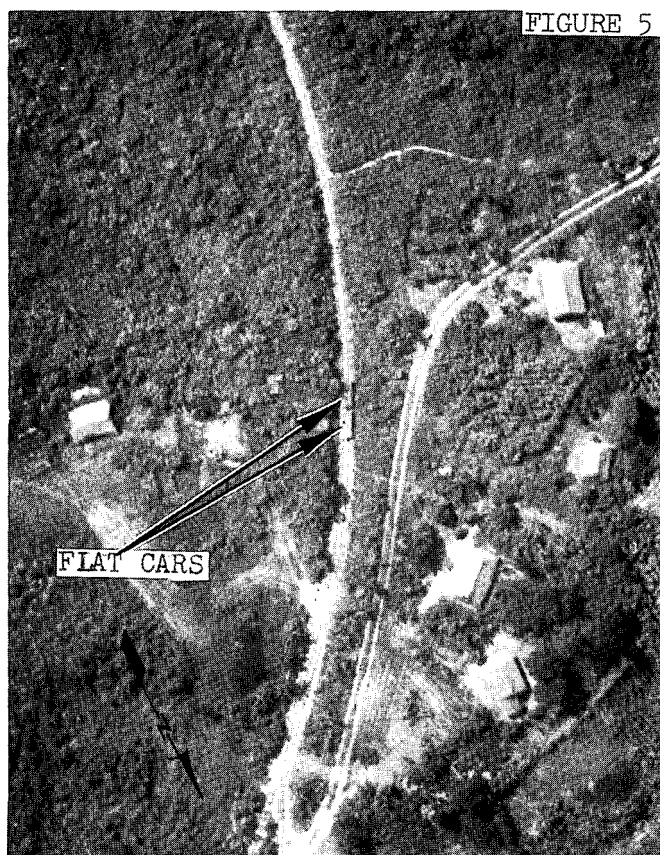
ITEM OF INTEREST NO. I: Hanoi/Dong Hoi Rail Line

NAME: Rolling Stock

Photography [REDACTED] revealed the presence of 2 flat cars 0.1 nm south of the Rao Nay (River). This segment of the Hanoi/Dong Hoi Rail Line is currently under construction and has not been joined to the operational portion of the rail line. The origin of the rolling stock is not known; it may have been transported by unknown means over the Rao Nay (River) or it may be old French equipment abandoned many years ago when this rail segment was destroyed.

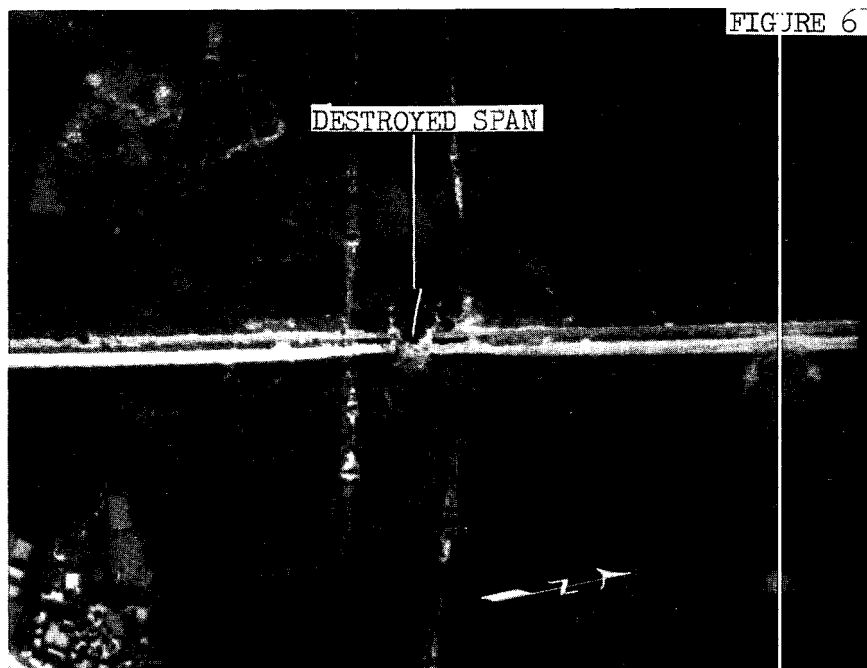
ITEM OF INTEREST NO. 2: Hanoi/Dong Hoi Rail Line

NAME: Dong Khe RR Bridge

Photography  revealed that the 3-span Dong Khe Railroad Bridge is unserviceable. The center span has been completely destroyed.

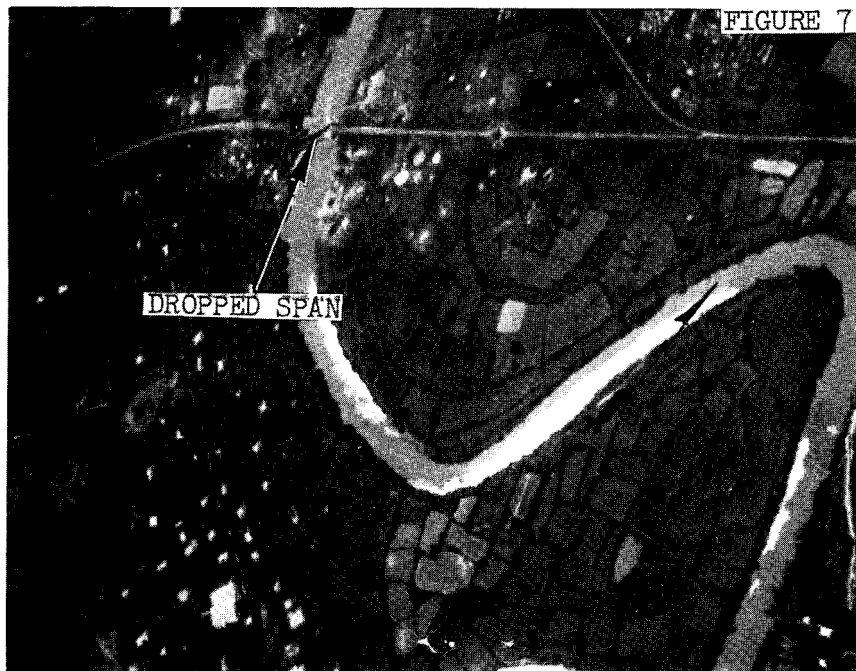
ITEM OF INTEREST NO. 3: Hanoi/Dong Hoi Rail Line

NAME: Dia Thuy RR Bridge

Photography  revealed that the single span Dia Thuy Railroad bridge has been dropped.

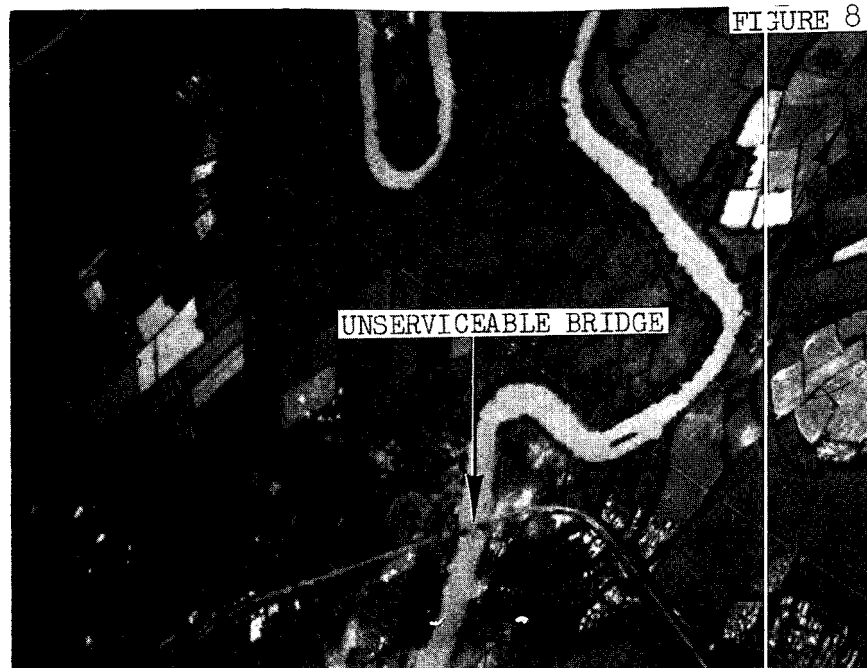
ITEM OF INTEREST NO. 3 (Continued): Hanoi/Dong Hoi Rail Line

NAME: Dia Thuy RR By-pass Bridge

revealed that the 6-span Dia Thuy Railroad By-pass Bridge is unserviceable. Two spans have been completely destroyed.

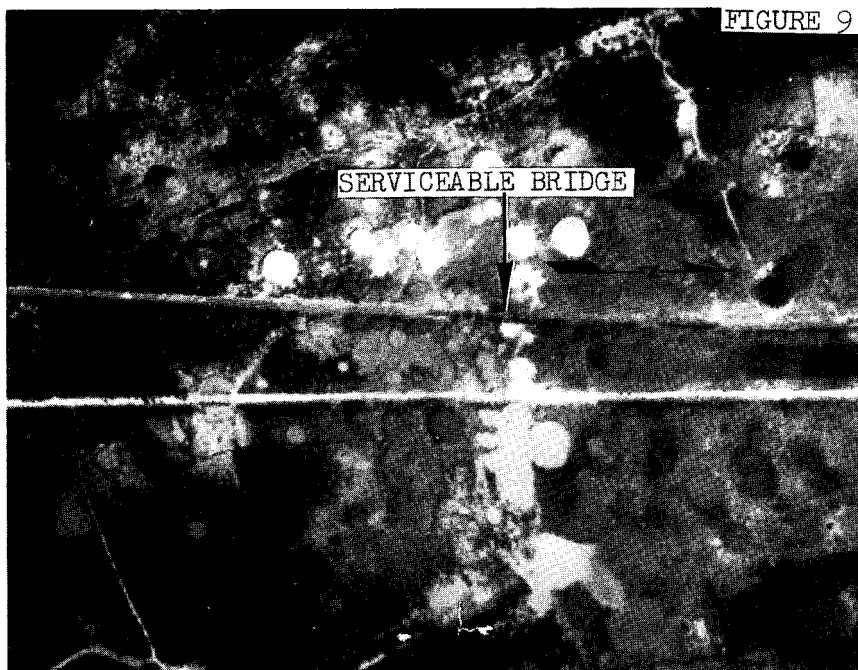
FIGURE 9

NAME: Phu Cu RR Bridge

Photography  revealed that the Phu Cu Railroad Bridge has been repaired and is probably serviceable.

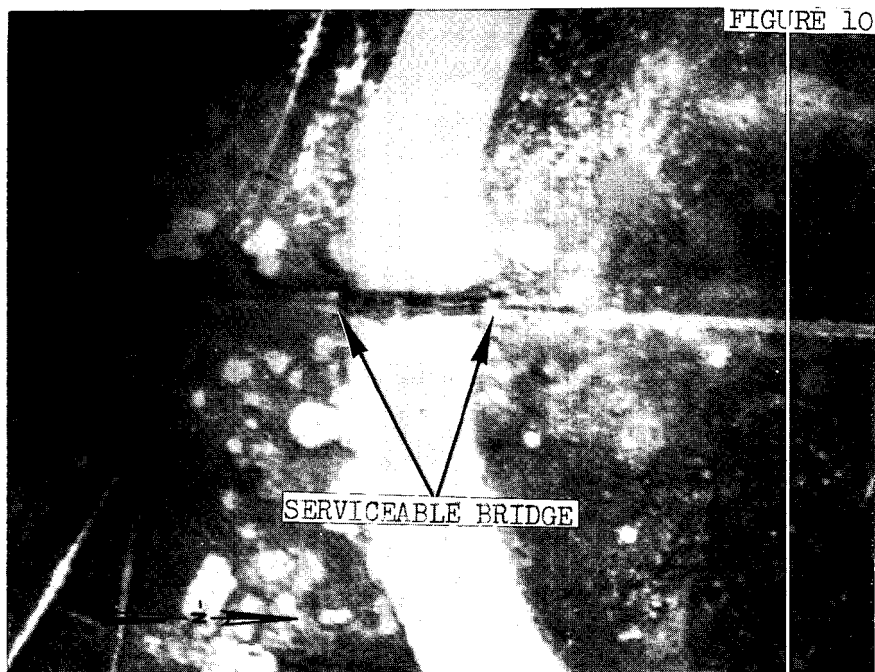
ITEM OF INTEREST NO. 5: Hanoi/Dong Hoi Rail Line

NAME: Trong Quang Tien RR Bridge

Photography  revealed that the Trong Quang Tien Railroad Bridge has been repaired and is serviceable. The by-pass bridge to the east remains serviceable.

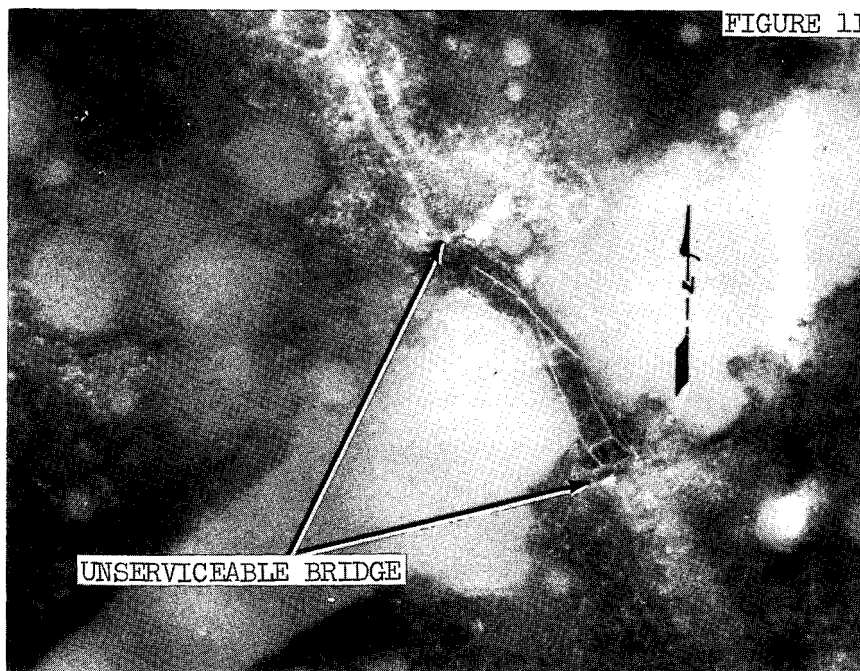
ITEM OF INTEREST NO. 6: Hanoi/Dong Hoi Rail Line

NAME: Thinh Lac RR Bridge

Photography [REDACTED] revealed that the Thinh Loc Railroad Bridge is unserviceable. Three spans have been destroyed. The by-pass bridge continues to be serviceable.

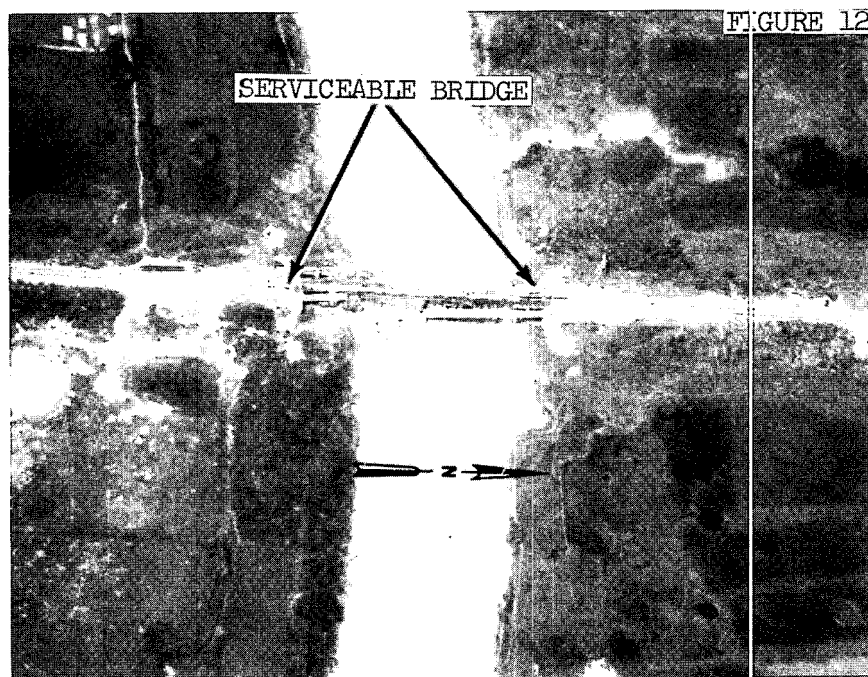
ITEM OF INTEREST NO. 7: Hanoi/Dong Hoi Rail Line

NAME: Thien Linh Dong RR Bridge

Photography  revealed that the Thien Linh Dong Railroad Bridge has been repaired and is serviceable.

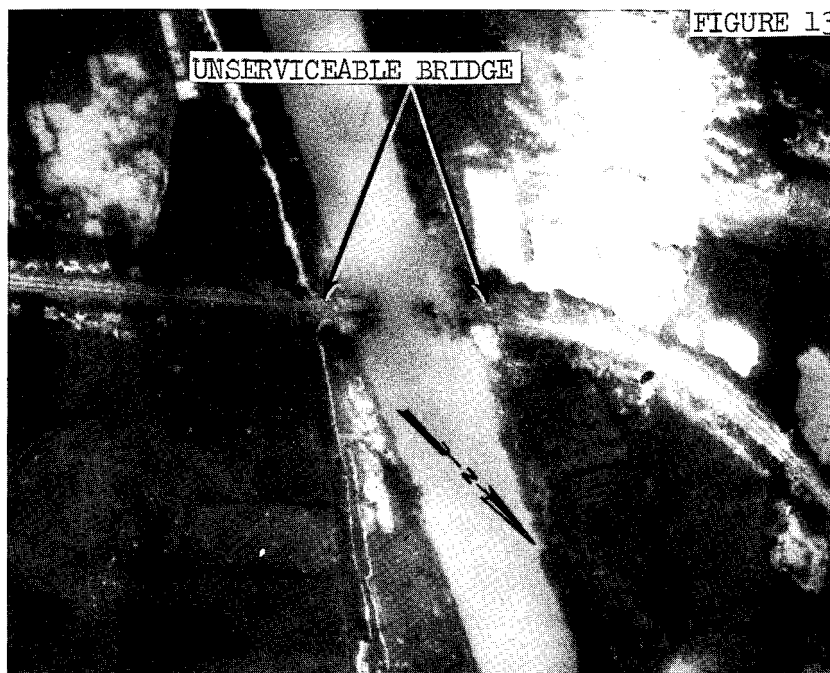
ITEM OF INTEREST NO. 7 (Continued): Hanoi/Dong Hoi Rail Line

NAME: Thien Linh Dong RR By-pass Bridge

Photography [REDACTED] revealed that the Thien Ling Dong Railroad By-pass Bridge has been destroyed.

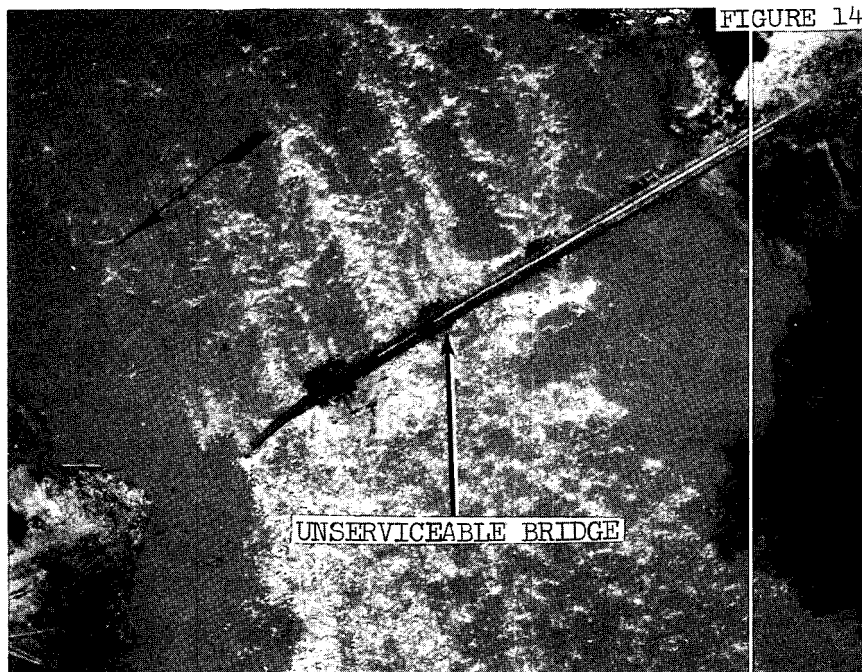
ITEM OF INTEREST NO. 8: Hanoi/Dong Hoi Rail Line

NAME: Dong Phuong Thuong RR By-pass Bridge West

Photography  revealed that the Dong Phuong Thuong Railroad By-pass Bridge West has been bombed. Two spans and one pier have been destroyed. All rail crossing facilities at this river crossing are now unserviceable.

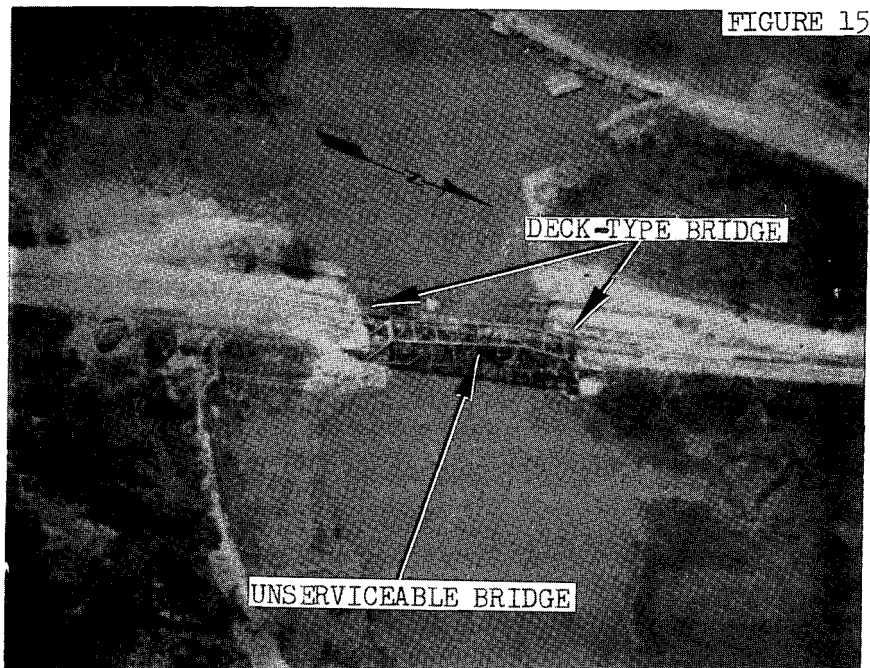
ITEM OF INTEREST NO. 9: Hanoi/Dong Hoi Line

NAME: Vu Lam RR Bridge

Photography  revealed that the Vu Lam Railroad Bridge remains unserviceable.

A deck-type replacement bridge has been constructed adjacent to the destroyed bridge and is complete and serviceable.

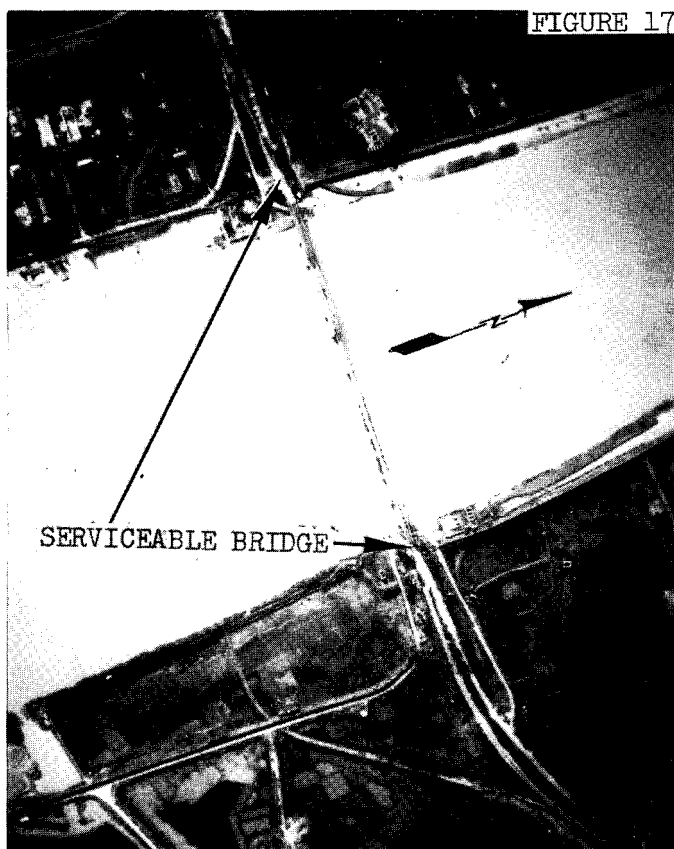
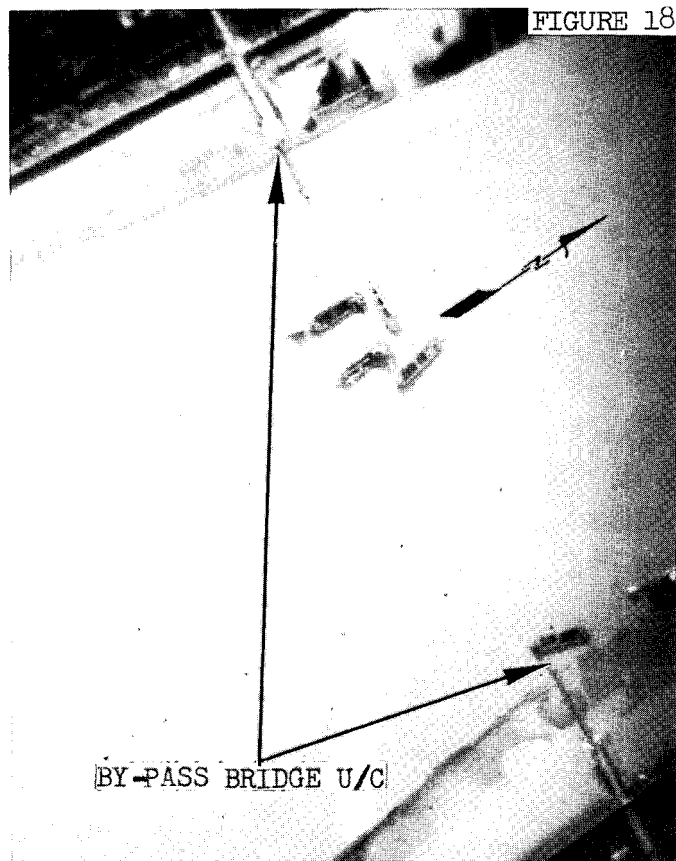
ITEM OF INTEREST NO. 1: Hanoi/Haiphong Line

NAME: Hai Doung RR and Highway Bridge

Photography  revealed that the Hai Duong Railroad and Highway Bridge has been repaired and is serviceable (Figure 17). Construction continues on the by-pass bridge to the north of the main bridge (Figure 18).
